**Post-flood investigation in the
Lower Chao Phraya River Basin**

Post-flood field investigation in the Lower Chao Phraya River Basin 23 - 27 January 2012

Findings of the Thai - Dutch Reconnaissance Team

Organized by ENW: the Dutch Expertise Network for Flood Protection

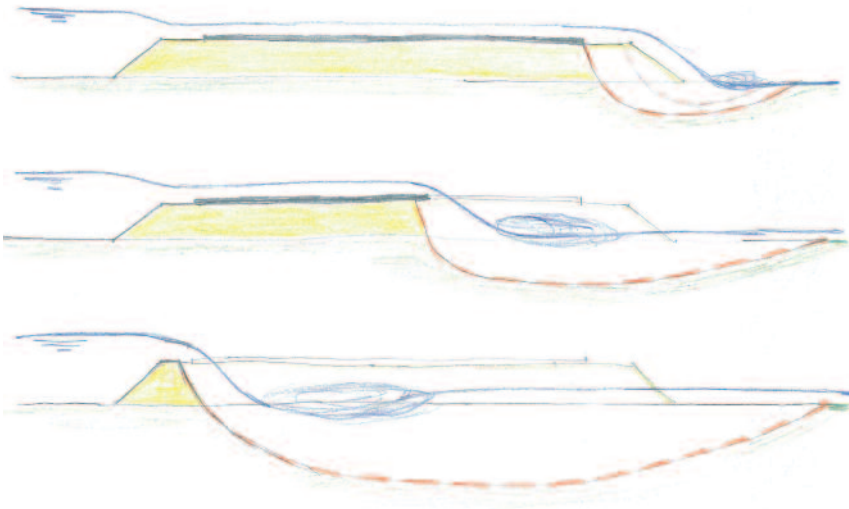
Failure mechanisms
Overflow of dykes was reported in large parts of the Lower Chao Phraya river Basin. The reported water depths on top of the dyke ranged from 0.3m to 1m. Most failure cases were due to overflow of water, consequent erosion of the dyke at the inner slope and formation of a breach (Figure 3.1). One of the largest breaches that was visited is described more in detail in Textbox 1.

Figure 3.1
Erosion of dykes due to overflow

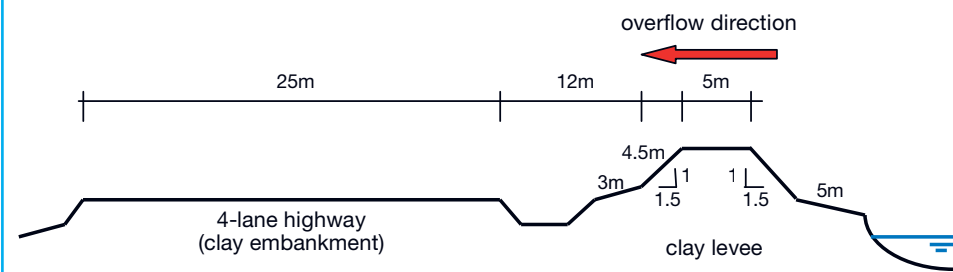
A four lane asphalt road was located behind the dyke. This four lane road was fully eroded in about two days. At the time of the visit a new two lane road was constructed at this site. The figures below show a picture of the situation during the time of the visit, and sketches of the plan view and cross section of the location. It is remarkable that such a wide structure, consisting of the dyke and road body, could be fully breached due to overflow. This is a relevant finding for the discussion in the Netherlands on wide / unbreachable dykes, sometimes also referred to as deltadykes. Especially since the road body consisted of clay, which in the Netherlands would be characterized as an erosion resistant material.

Figure 3.3
Schematic cross section of the Manorom dyke near chainat (location km 2 +650) in the pre-flood situation.

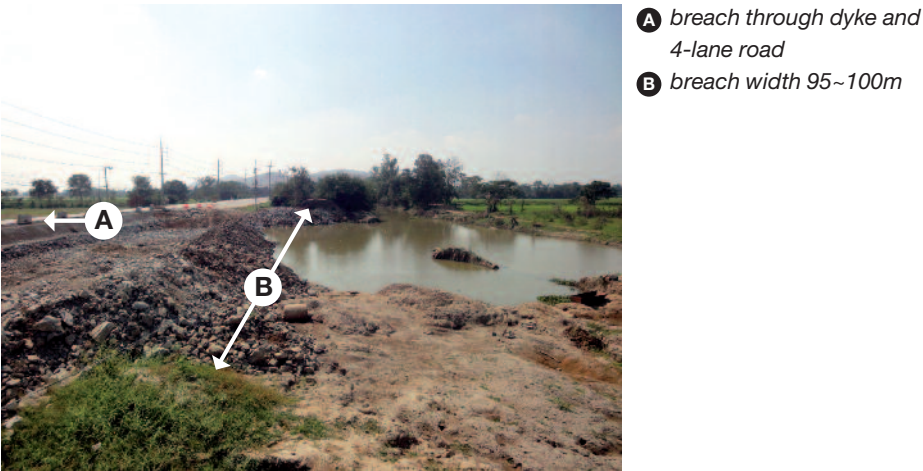
Several breaches occurred in the Manorom dyke near the city of Chainat. The largest breach occurred at the location km 2 +650. This failure was caused by overflow and this resulted in a breach of about 100m wide.

Figure 3.4
Breach in the Manorom dyke near Chainat (location km 2 +650)

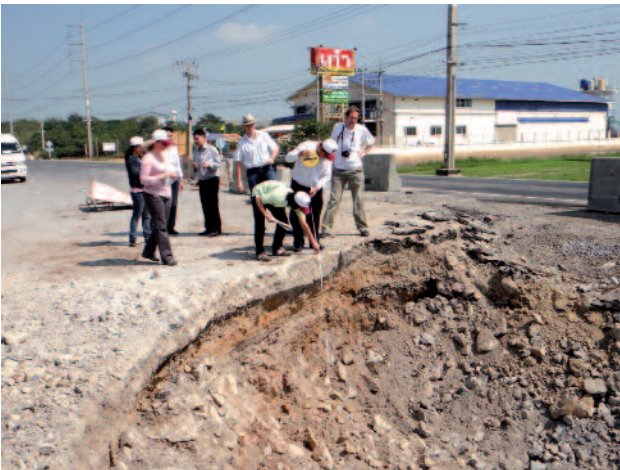
Figure 3.5
Measuring the breach in the Manorom dyke near Chainat (location km 2 +650)

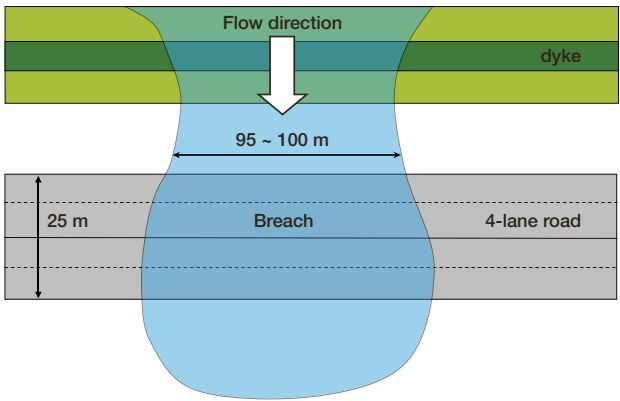
Figure 3.6
Schematic plan view of the breach in the Manorom dyke near Chainat (location km 2 +650)

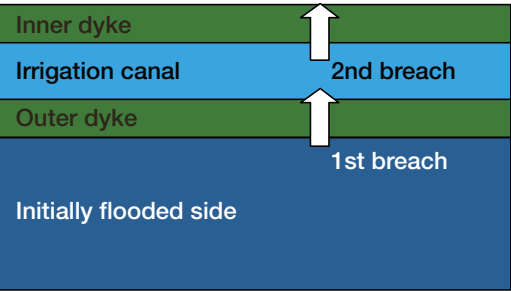
In many situations two parallel dykes were breached. They formed the boundaries of the irrigation canal (see Figure 2.5). Overflow, and consequent erosion and breaching of the outer dykes led to an increased hydraulic impact on the second dyke. In many cases it was observed that both canal dykes breaches at the same location.

Figure 3.7
Schematic plan view of double breaches in the dykes of the irrigation canal

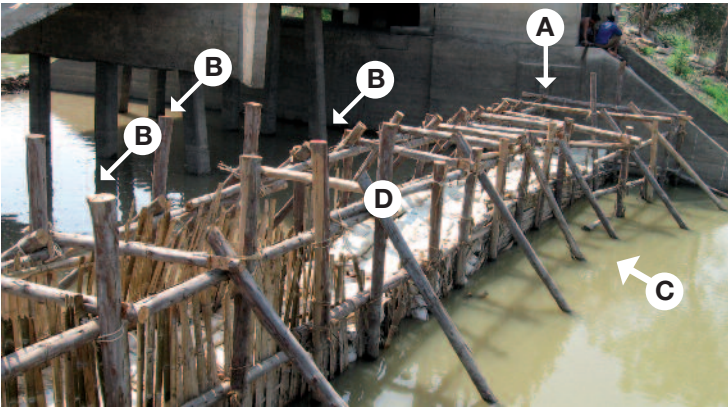
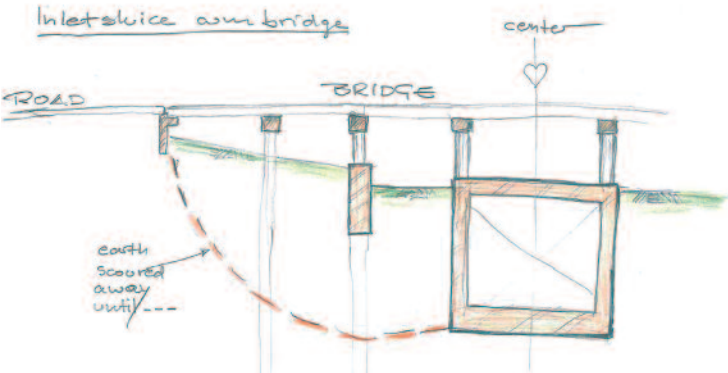
- The structures were mainly designed for irrigation and not so much for flood control. During the 2011 events the structures experienced higher loads and sometimes loads from a different direction than during normal irrigation conditions. During the floods sandbags were placed on top of the structure to prevent or reduce overflow.
- All the structures that were visited failed at the connection of the structure and the earthen dyke. This indicated how vulnerable these connections are ².

- Because the structures are mainly designed for irrigation purposes with small water heads, provisions to prevent seepage / piping during floods seem to be limited, especially on the connection with the adjoining dykes or dam. Thereby scouring and breaching could occur besides the structures. This is illustrated in Figure 3.8 (Klong Ta Nueng floodgate) and Figure 3.9 (Pra Ngam floodgate), which show a photo of the situation and a sketch of the failure.

- Ⓐ connection of front wall
- Ⓑ soil washed away
- Ⓒ flow during flooding
- Ⓓ temporary coffer dam

Figure 3.8
Failure of the Klong Ta Nueng floodgate

- It was indicated by employees from RID that seepage screens / front walls will be placed in permanently repairing the floodgates. The use of rock fill and gabions introduces a new problem. It is very difficult, if not impossible, to drive sheet piles through the rock fill or to excavate trenches to construct seepage walls next to the structure. A point of attention is the size of the screen. The screens should be wide and deep enough to prevent seepage and erosion of materials under and besides the structure. A last point of attention is the connection of the front wall / seepage wall to the structure. At the field visits no reinforcing steel rods were seen sticking out of the structure. Therefore it is expected that there was no connection between the structure and the original front wall that could transfer loads.

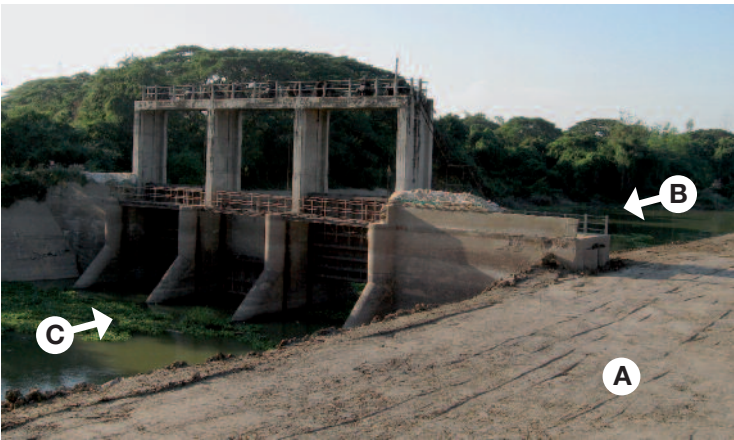
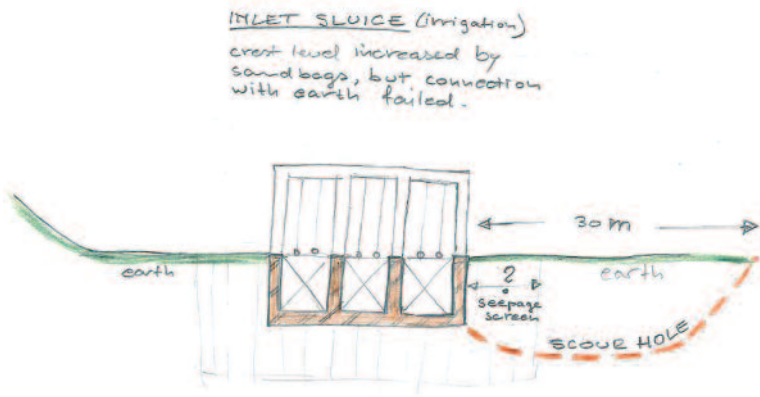
- Ⓐ sand fill at the original breach
- Ⓑ regular flow
- Ⓒ flow during flooding

Figure 3.9
Failure of the Pra Ngam floodgate

- A separate rock-fill closure dam was constructed behind the Pra Ngam floodgate to close the canal. For the initial closing of the gaps gabions and loose rock fill were used. In the last stages of the closure single gabions were washed away due to high flow velocities. In that case up to 8 gabions were tied together. Later the rock fill is covered with compacted clay and revetments. These are temporary measures.

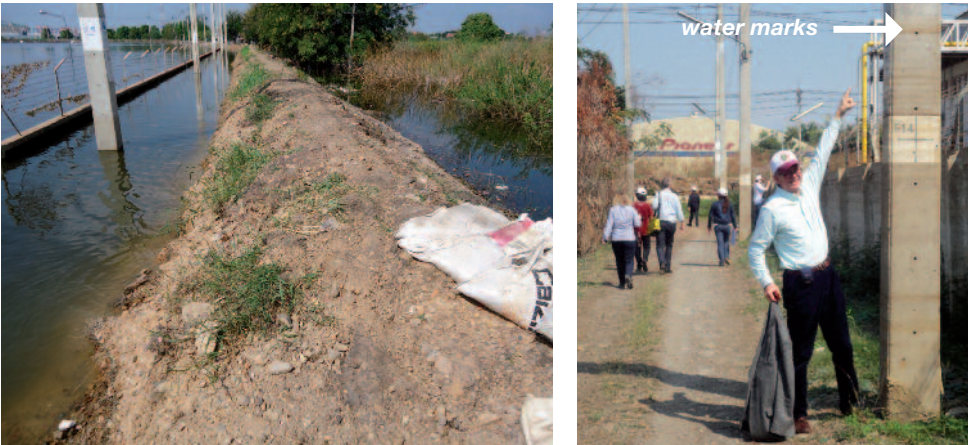
The flood levels were higher than the flood defences and led to overtopping and consequent breaching of the dykes. In total seven breaches occurred, most of those due to severe overtopping. Flood depths up to 3 meters occurred within the estate (Figure 3.10).

Figure 3.10
Left: Dyke section at Rojana Industrial Estate during the 2011 floods (Oct. 8th, 2011);
Right: Water marks indicating the flood levels within the estate

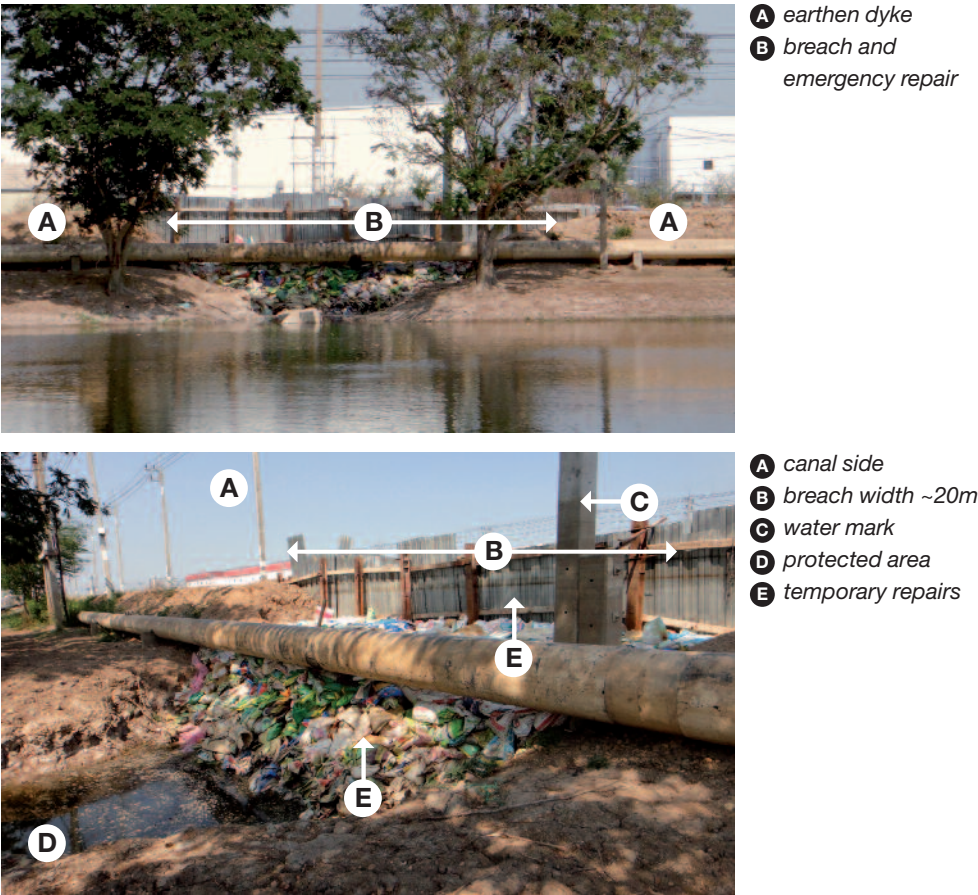
Two breaches were visited. The first breach was caused by overtopping and it had a width of about 20m. The canal levee had been raised as flood fighting measure by 0.5m with a backhoe. Still, the final flood levels exceeded the crest level by far (0.8 ~ 1.0m). The pipe along the slope and the columns on the protected area side may be speculated to have contributed to the erosion failure. The failure had occurred after no more than 6 hours after the levee started being overtopped.

Figure 3.11
First breach visited in Rojana Industrial estate

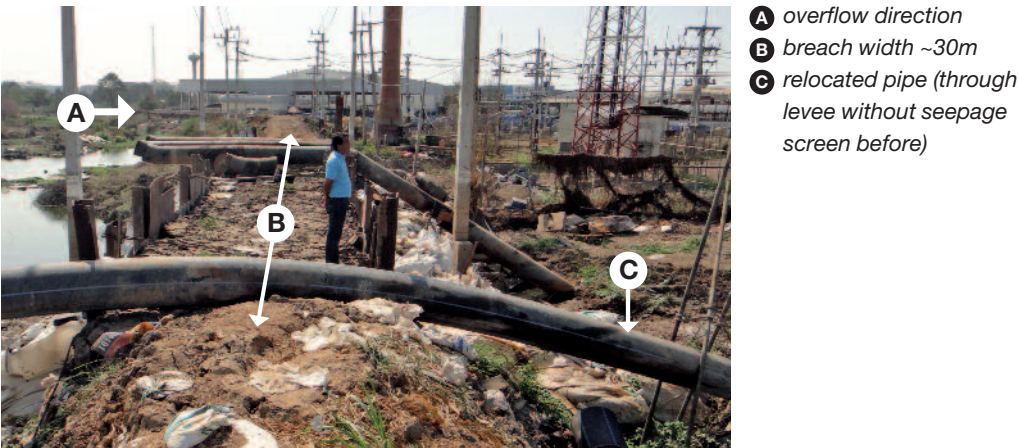
The second breach that was visited occurred at a pipe in the dyke, which was not protected by seepage screens. At this location the failure started with seepage along a pipe through the levee (no seepage screen) and failure progression accelerated when it was also overtopped. According to eye witnesses it took about 2 hours to form the 30 wide breach. The levee was rather new and built after floods in 1999.

Figure 3.12
Breach at Rojana Industrial Estate (location 2) from canal side

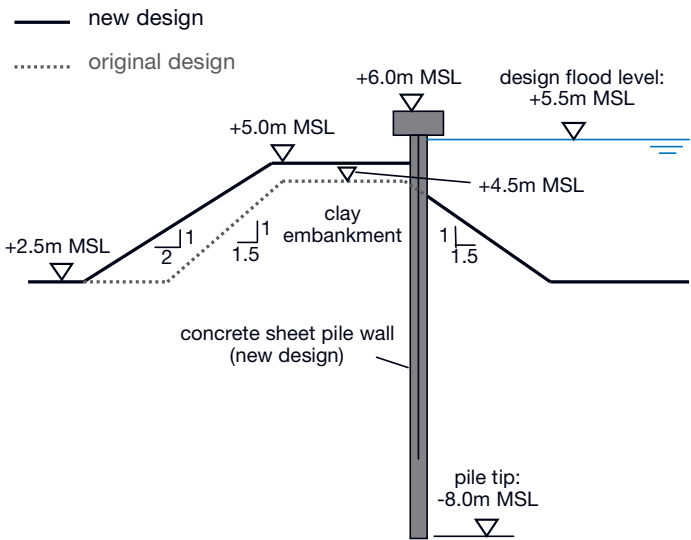
Figure 3.13
Original and new design of the dykes around Rojana estate

At the time of the visit the industrial estate already had plans to reinforce levees around the area before the next flood season. The figures below show the original as well as the new designs. In the new design, the earthen dyke is strengthened and heightened by 1.5m by means of floodwall. About 10m long sheetpiles are used to prevent instability and seepage.

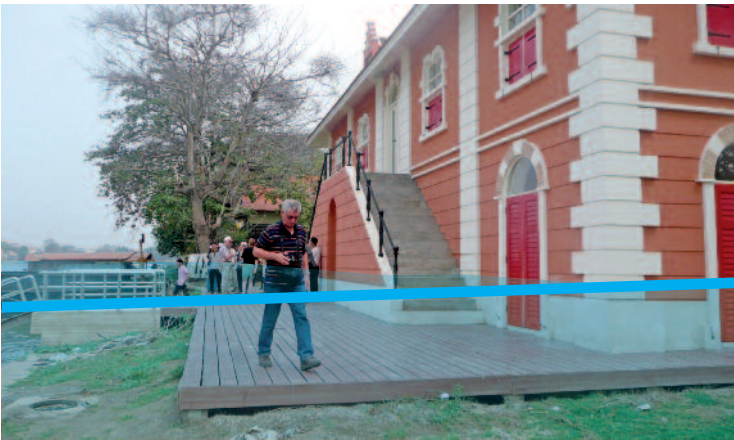
Baan Hollanda (Holland House) is a reconstructed historical Dutch settlement that is located on the banks of the Ayutthaya river. It was flooded by about 1m of water during the events in 2011 (Figure 3.14). It took a team of about 20 people a week to clean-up this site. The representative from the embassy made a request to the Dutch experts to develop solutions to prevent flooding of Baan Hollanda in the future.

Figure 3.14
View on Baan Hollanda from the riverside, and indication of the flood level during the 2011 floods

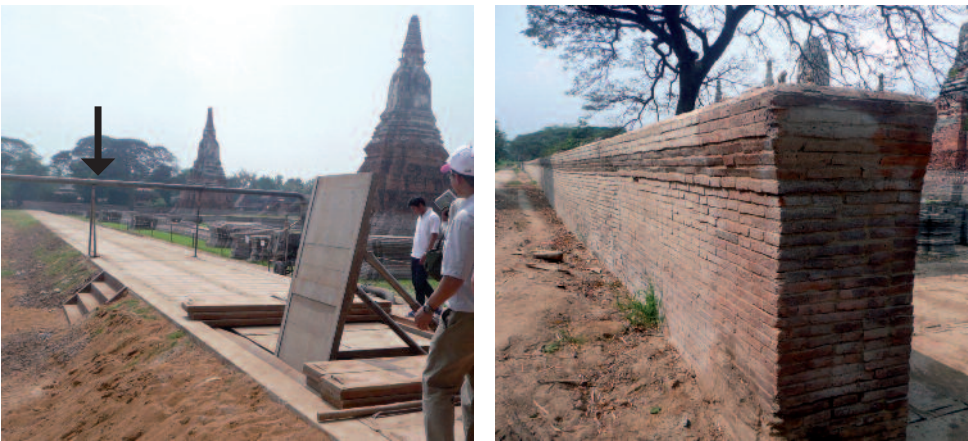
The Wai Chai Wattanaram temple is also located at the river banks. It is protected by movable flapgates on the river site and masonry walls on the other sites of the area. Flooding occurred at the southern corner at the connection of the movable gates and the wall, illustrating the vulnerability of such connections. The exact cause of flooding (overflow due to local waterlevel rise and/or breaching of walls) could not be determined on-site. The flooding has had a severe impact and most of the site is still closed for the public. Both cultural sites could be used as very visible ‘beacons’ to monitor flood risk resilience during future floods.

Figure 3.15
Movable floodgates at The Wai Chai Wattanaram temple (left) and location of connection at southern end of the terrain where flooding occurred (right)

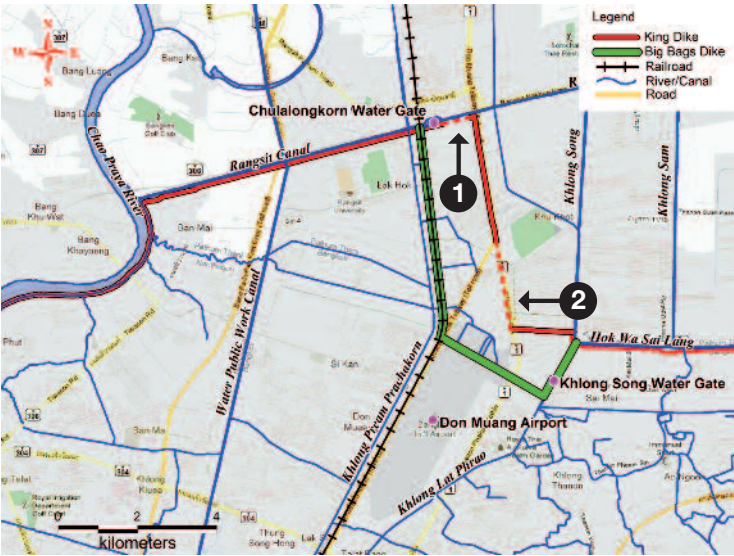
The team has made a short visit to parts of the King’s dyke around Bangkok. At most of the locations the dyke is integrated in the road system and has a limited elevation ranging from +1.0 to 2.9m (MSL). At some locations the dyke is not present. The team visited one of these sections. The flooding that occurred due to missing sections of the dyke resulted in flooding of parts of Bangkok, including the Don Muang airport.

Figure 3.16
Openings (1 and 2) in the King’s dyke on the Northern side of Bangkok and the temporary dyke of big bags
