**Post-flood investigation in the
Lower Chao Phraya River Basin**

Post-flood field investigation in the Lower Chao Phraya River Basin 23 - 27 January 2012

Findings of the Thai - Dutch Reconnaissance Team

Organized by ENW: the Dutch Expertise Network for Flood Protection

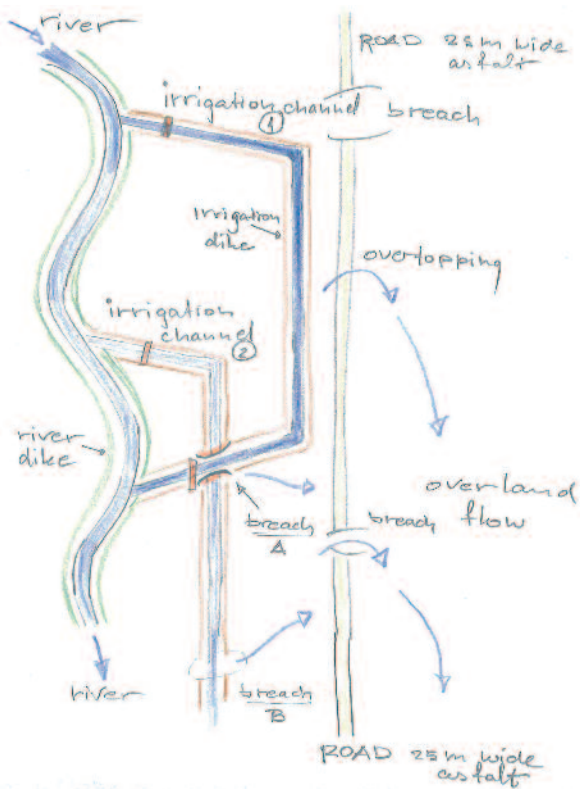
Figure 2.3
Schematic plan view of a typical situation in the Lower Chao Phraya River Basin

The Lower Chao Phraya river basin is a complex network of rivers, canals and streams. A schematic characterization of the system of the part that the team visited between Sing Buri and Chainat is shown in (Figure 2.3 - plan view) and (Figure 2.4 - cross section). These figures show a typical situation east of the river. During the floods the floodwater overflowed the river banks and then impacted the canal dykes, which breached at some locations. Several canals connect the river and the parallel canal system, and hydraulic structures are present to regulate the flow between both systems.

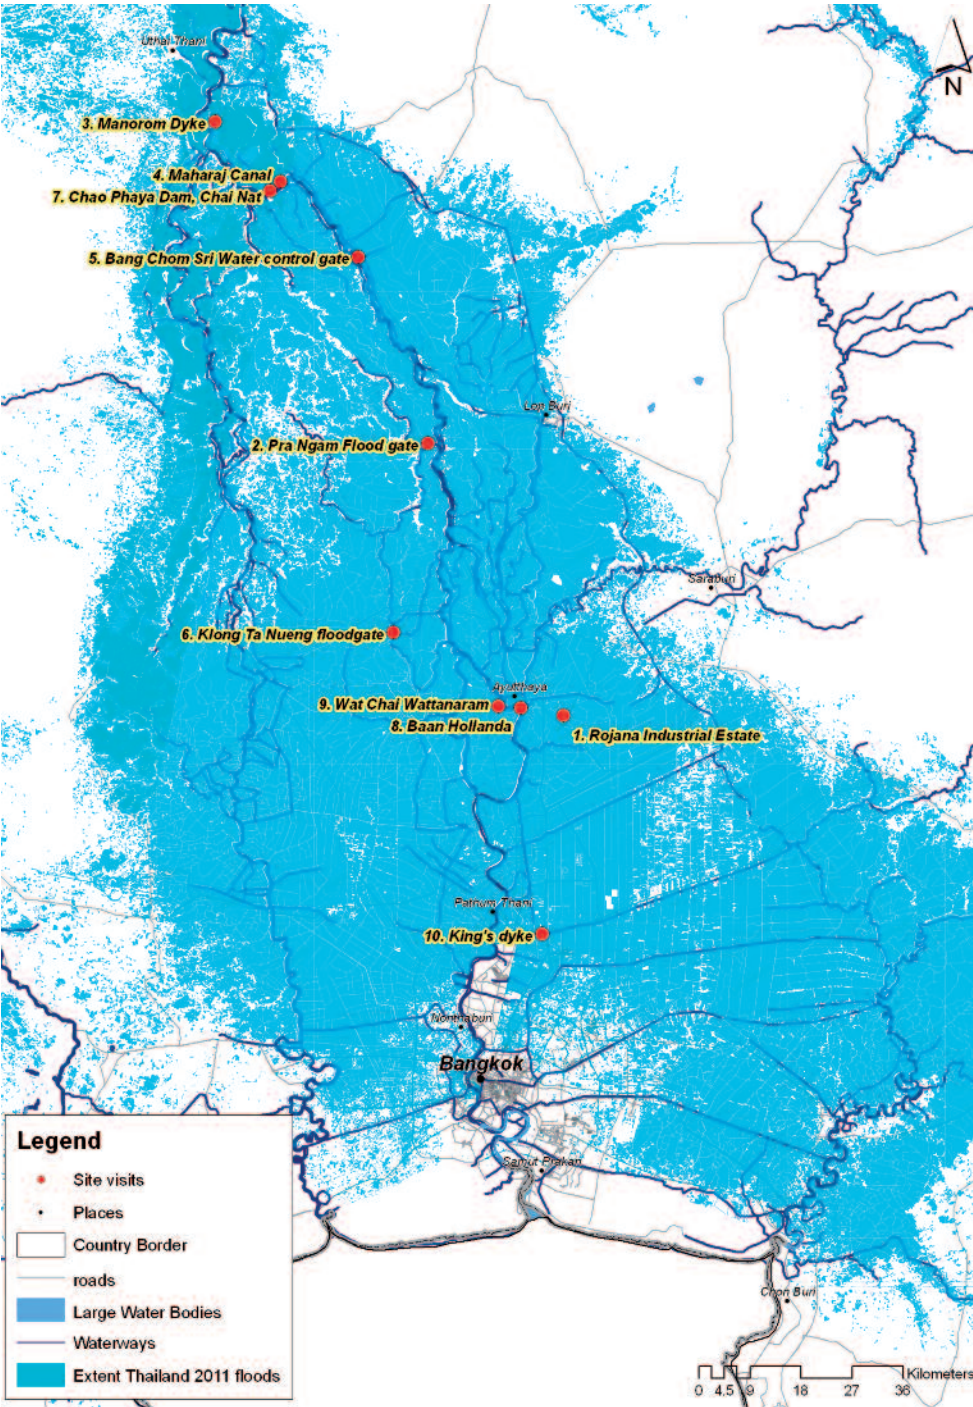
Figure 2.5
Overview of the 2011 flood extent and the locations that were visited during the field investigation

In many situations two parallel dykes were breached. They formed the boundaries of the irrigation canal (see Figure 2.5). Overflow, and consequent erosion and breaching of the outer dykes led to an increased hydraulic impact on the second dyke. In many cases it was observed that both canal dykes breaches at the same location.
